High-voltage tower failures in South Australia

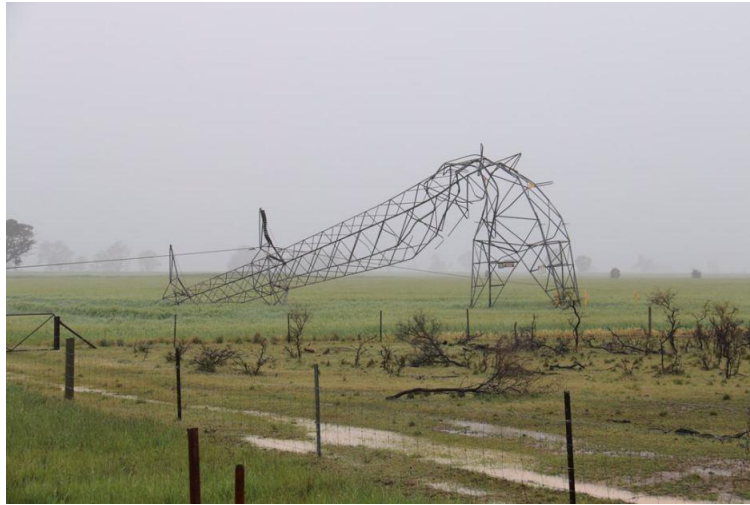
The failure of 23 high voltage towers in South Australia on September 28 is unfortunately not an uncommon event. There have been at least 12 similar events in that state since 1962. The causes in nearly all of these are severe downdraft winds from thunderstorms also known as 'downbursts' or 'microbursts'; in the transmission line industry they are also known as 'high-intensity' winds. These can generate a storm front several kilometres wide that will envelope several transmission line spans, loading both the transmission lines and their supporting towers.

The north-south running lines in South Australia, north of Adelaide, are particularly vulnerable as the strong winds approach from the west, thus applying the maximum load on the lines, which then are applied to the towers. A risk study carried out by wind engineering consultants, JDH Consulting, and meteorological consultants Weather Solutions, in 1998, found that the risk to north-south lines is about six times greater than that for east-west running lines in that part of South Australia.

Australian Standard 7000 published in 2010 provides design rules for new transmission line structures to resist downdrafts, and is a world first in recognizing the importance of such events to designers, but of course there are many legacy structures in Australia that have not yet been upgraded to resist the loadings applied.
